Do Steel Bridges Prevent Rail Corrugations?

Peter Meinke*
Johannes Stephanides**

Abstract

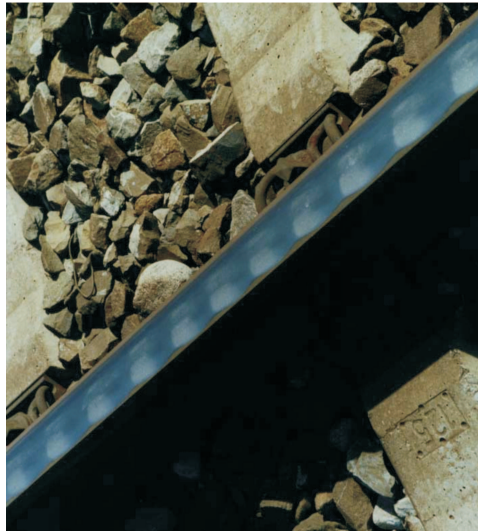
Fig. 1. Wear pattern on the rail head of a narrow curve [1]

Rail corrugations (german: “Schlupfwellen”) are wear pattern, which emerge during the transits of railway vehicles in narrow railway curves (Fig. 1).

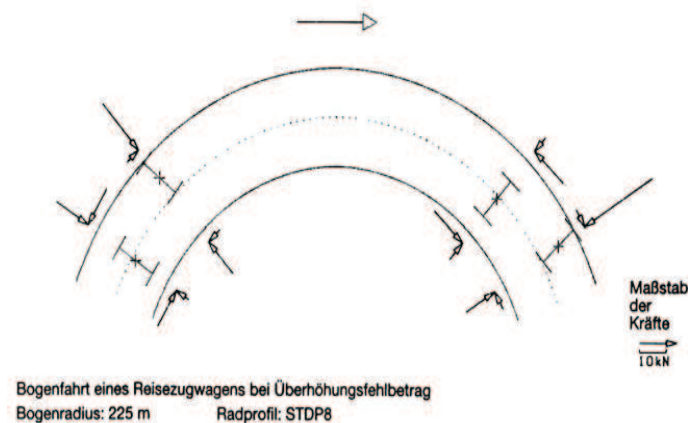
Fig. 2. Simulation of the wheel set positions of a 4 axle-vehicle in a narrow curve [2]

and torsion of the wheel set axle occurs [1], because the wheel set does not adjust itself deliberately into a proper curve passing position (Fig. 2).

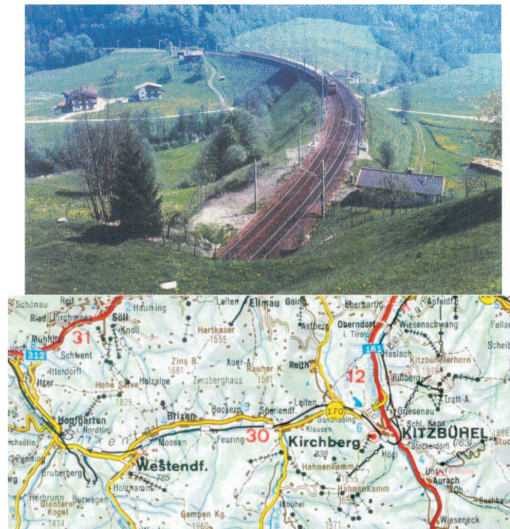
Fig. 3. Test curve of Brixental between Hopfgarten and Westendorf

In 2001 the Österreichische Bundesbahn (ÖBB) started within the frame of the research project “OBO” (optimierter Bogenoberbau) investigations of the mechanics of rail corrugation and trying – if possible – the development of remedial actions against the undesired wear phenomenon. As a test curve for the mainly experimentally oriented undertaking the “Brixentaler Bogen” was chosen (Fig. 3),

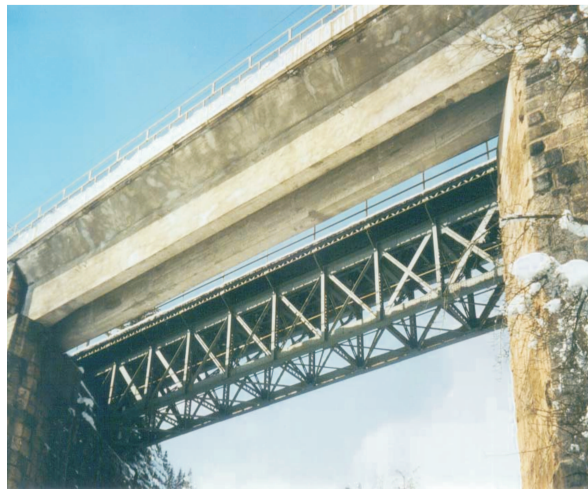
Fig. 4. The railway line traverses at the „Hohe Brücke“ the river “Windacher Ache”

This bridge shows a very funny feature: The up-hanging part of the bridge is constructed by iron, whilst the downwards bridge part is made from concrete (Fig. 4).

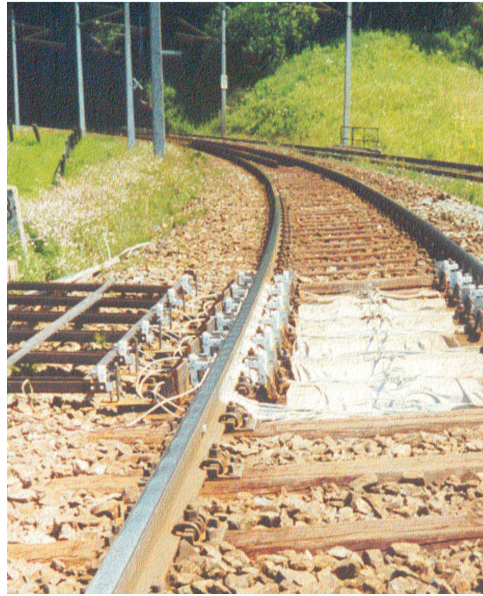
Fig. 5. The measurement site in the ballasted track (see the rail corrugations!)

huge numbers of rail corrugations! As it was not clear to the OBO-team, whether there is some influence to the generation of rail corrugations by the track bed (which is different in the case of the ballasted track from the bridge track), it was decided to install two identical measurement sites (constructed in the same way), as well at the ballasted track as that of the bridge (Fig. 5, 6).

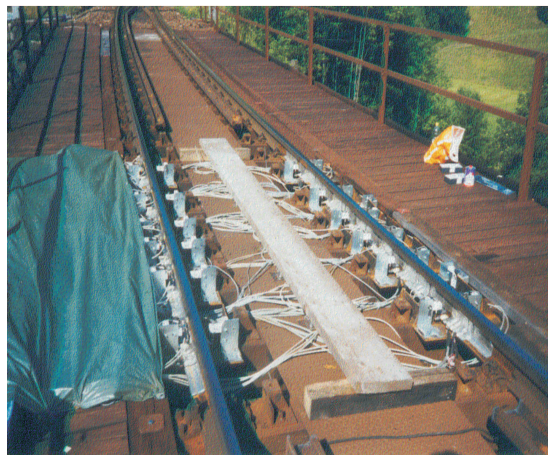
Fig. 6. The measurement site on the steel bridge (without rail corrugations!)

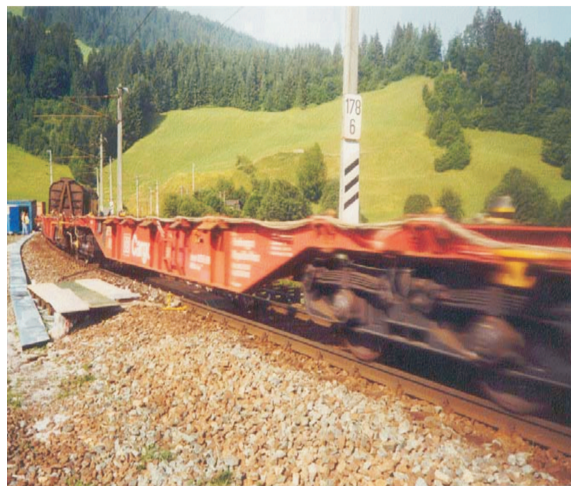
Fig. 8. The test train, passing the reference measurement equipment (km 178,6)

The test procedure was done in that way, that the test train was pulled upwards by the locomotive at the upper end, and afterwards rolling downwards with the default test speed by the locomotive at the down end of the train (Fig. 8). By this campaign a lot of measurement results were gained...

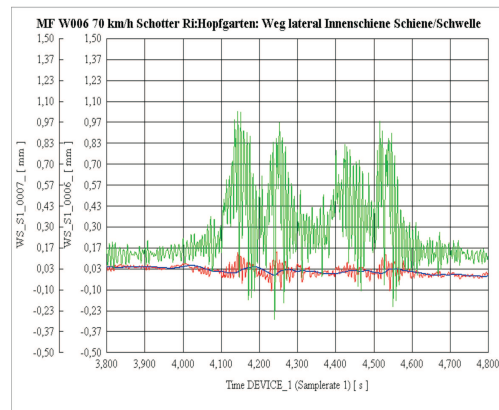
Fig. 9. The lateral displacement vibration of the inner rail head (green colour), the lateral displacement (red colour) of the associated rail foot and the filtered vertical displacement of the same rail head (blue colour) for identification of the position of the wheel sets; Sgns Y25 is going behind Sgns DG 652/640

For the purpose of our paper we select from the immense number of measurement results only those, which are important for our conclusions presented in this paper. We see in Fig. 9 the lateral displacement vibration of the inner rail head (green colour), the lateral displacement (red colour) of the associated rail foot and the filtered vertical displacement of the same rail head (blue colour) for identification of the position of the wheel sets; Sgns Y25 is going behind Sgns DG 652/640. One can see, that the rail is mainly inclining. The consequences are, that bending of the wheel set axle occurs, and that severe creepage in the contact area is to be expected! Fig. 10 shows the respective power spectral density.

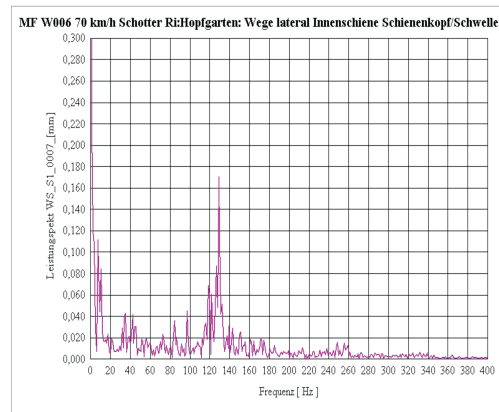
Fig. 10. Power spectral density of the inner rail head vibration

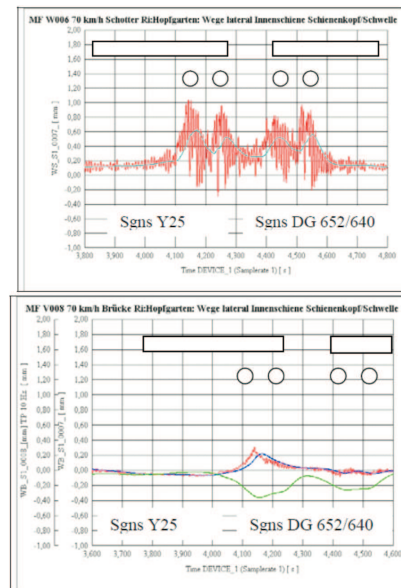
Fig. 11. Lateral displacements (as Fig. 9) at the ballasted track, compared with the equivalent signals at the bridge; Sgns Y25 is going behind Sgns DG 652/640

Now we compare the above measured results with Fig. 11:

The rolling on a narrow curve at a steel bridge is much more quiet than on ballasted track!! No rail corrugation occurs.

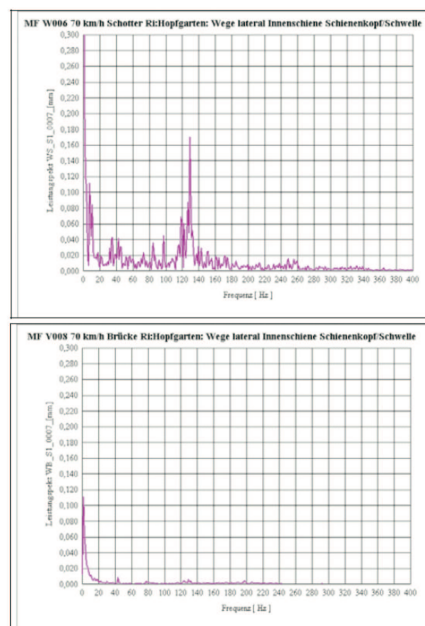
Fig. 12. Lateral power spectral density for the time signals of Fig. 11

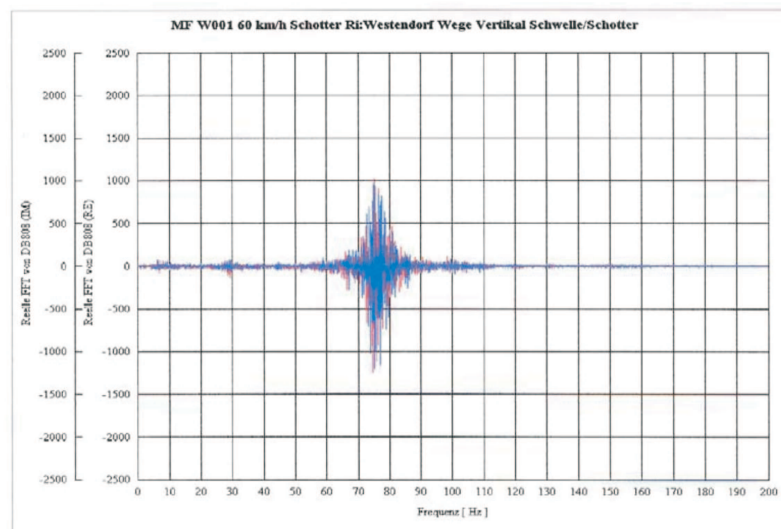
Fig. 13. Ballasted track, power spectral density of vertical sleeper vibration

In Fig. 13, 14 the power spectral density of the vertical vibrations of the sleeper in the case of ballasted track is compared with the sleeper of the steel bridge. One can clearly see, that the broadband vibration, caused by the structure of the steel bridge, is beneficial for avoidance of rail corrugation. You can even hear the change of noise, when you are sitting in a train, passing suddenly a steel bridge.

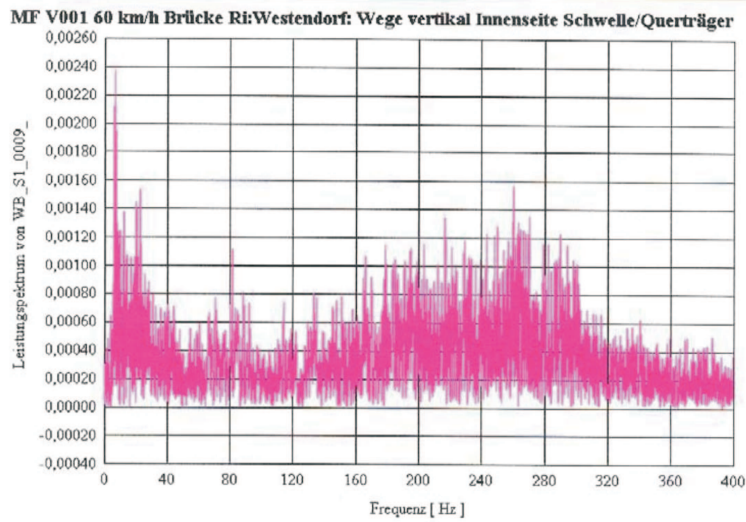
Fig. 14. Steel bridge, power spectral density of vertical sleeper vibration

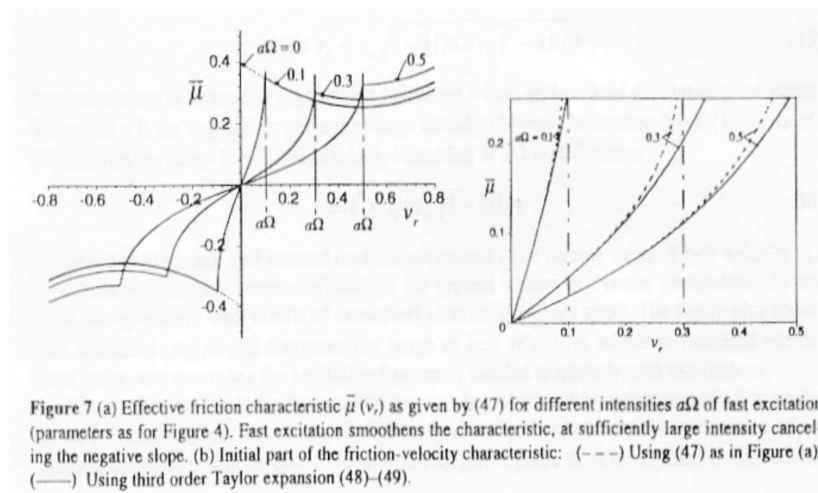
Figure 7 (a) Effective friction characteristic $\bar{\mu}(v_r)$ as given by (47) for different intensities $\alpha\Omega$ of fast excitation (parameters as for Figure 4). Fast excitation smoothens the characteristic, at sufficiently large intensity canceling the negative slope. (b) Initial part of the friction-velocity characteristic: (---) Using (47) as in Figure (a); (—) Using third order Taylor expansion (48)-(49).

The reduction of the friction coefficient by vibration of the contact area can be found also in the literature: Eg Thomsen [3] described such experiments:

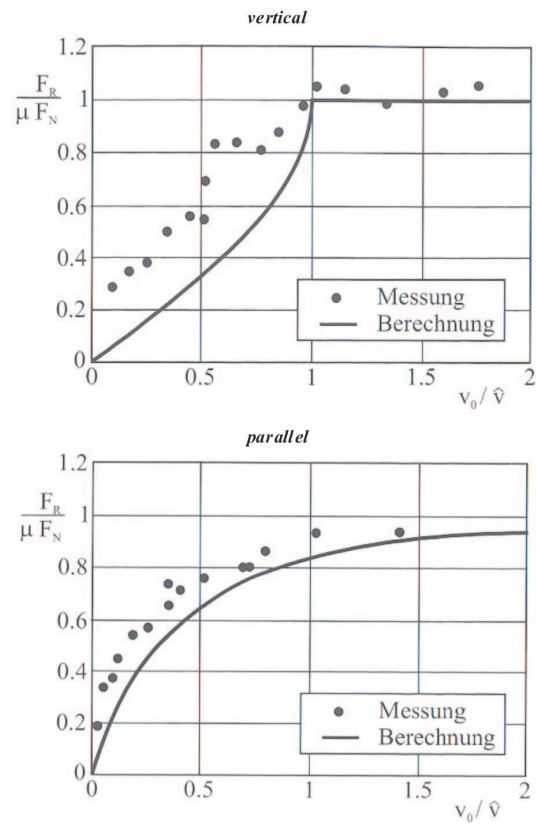
Fig. 15. The influence of vibration on the friction coefficient

Also Popov [4] came to the same result by theoretical and experimental research of Coulomb's friction (Fig. 15).
