THERMAL IMAGING DIAGNOSTICS IN INNOVATIVE RAILROAD SWITCH HEATING SYSTEMS

Toruń, A., Młynczak, J., Kukulski, J., & Stypulkowski, K. (2025). Thermal imaging diagnostics in innovative railroad switch heating systems. *Archives of Transport*, 76(4), 75-92. <https://doi.org/10.61089/aot2025.8hs1vf40>

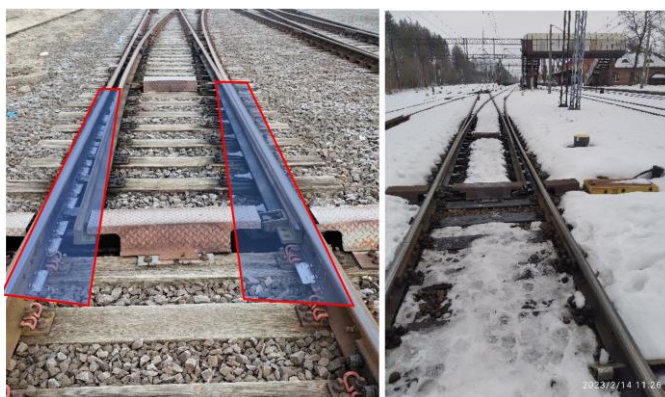
Fig. 1. Heating working area of the stock rails for the right and left half-switch

Additionally, the heating time as well as the process of preheating the switch elements were taken into account. Figure 1 shows the heating working area of the stock rails considered during the conducted studies.

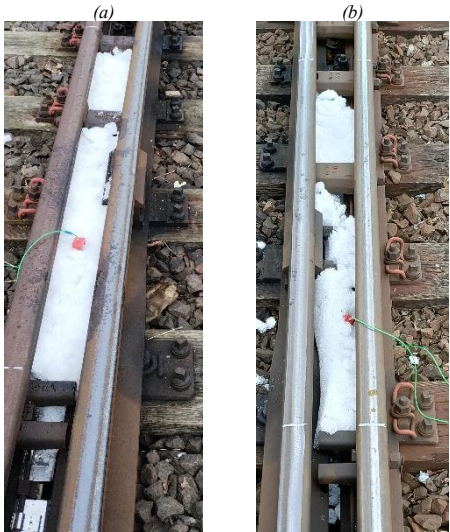
Fig. 4. View of the location of thermoelectric sensors installed on the studied switches No. 38 (a) and reference switch No. 39 (b) in the area covered with snow

Thermographic studies were conducted using a Flir SC660 thermal imaging camera and a Flir 1020. Measurements were carried out according to the procedure described in section 3.1 of the article. Simultaneously with recording the distribution of apparent temperature using the thermal imaging camera, the temperature was measured at selected points of the switch using an HD32.8.16 Guenther data logger with thermoelectric temperature sensors. The location of the measuring sensors in various places of the switch is shown in Figures 4 and 5.

One of the goals of this solution was to obtain information and data on the heating temperature values of selected switch components associated with the ESH heater system (Figure 4). Calibration (comparison) of thermal images and measurements using thermoelectric temperature sensors was also carried out to verify the correctness of the accepted emissivity coefficient.

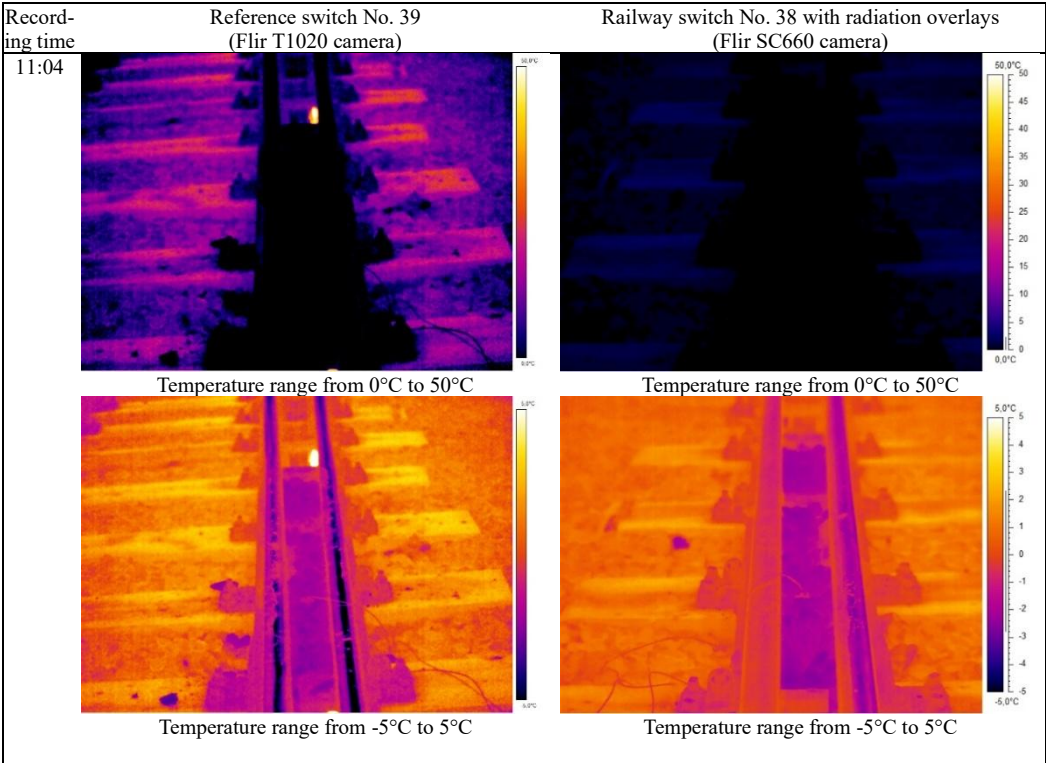
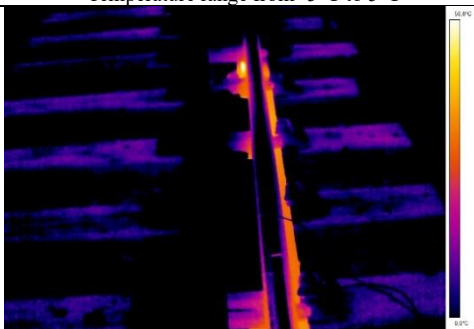
Fig. 6. Thermographic test results for switch No. 38 and 39 in the snow-covered area

Field tests of heat distribution using thermal imaging cameras and thermoelectric sensors were conducted at the Międzylesie research polygon from February 11 to 13, 2025. Reference switch, reference switch No. 39 type Rz-60E1-1:9-300 with an installed power of 7.3 kW was compared to switch No. 38 of the same type, in which NR radiation overlays were installed. The same type and number of heaters were installed on both switches according to the ESH sheet. The difference was that switch No. 38 with NR radiation overlays was heated with a 30% reduced power. Heat distribution comparison was conducted, among other methods, thermographically. In Figure 7, the measurement results are compiled in the form of thermograms, for which the same temperature range was adopted for both switches from 0 to 20°C, as well as from 0 to 50°C. An isotherm tool was also used, which visually highlights the

differences between both technical solutions. It is clearly visible that the switch equipped with NR radiation overlays has a significantly larger share of areas with higher temperatures in the defined temperature ranges, thus its heat distribution efficiency is higher than that of the reference switch. In this solution, thermal energy is distributed for snow melting rather than rail heating.

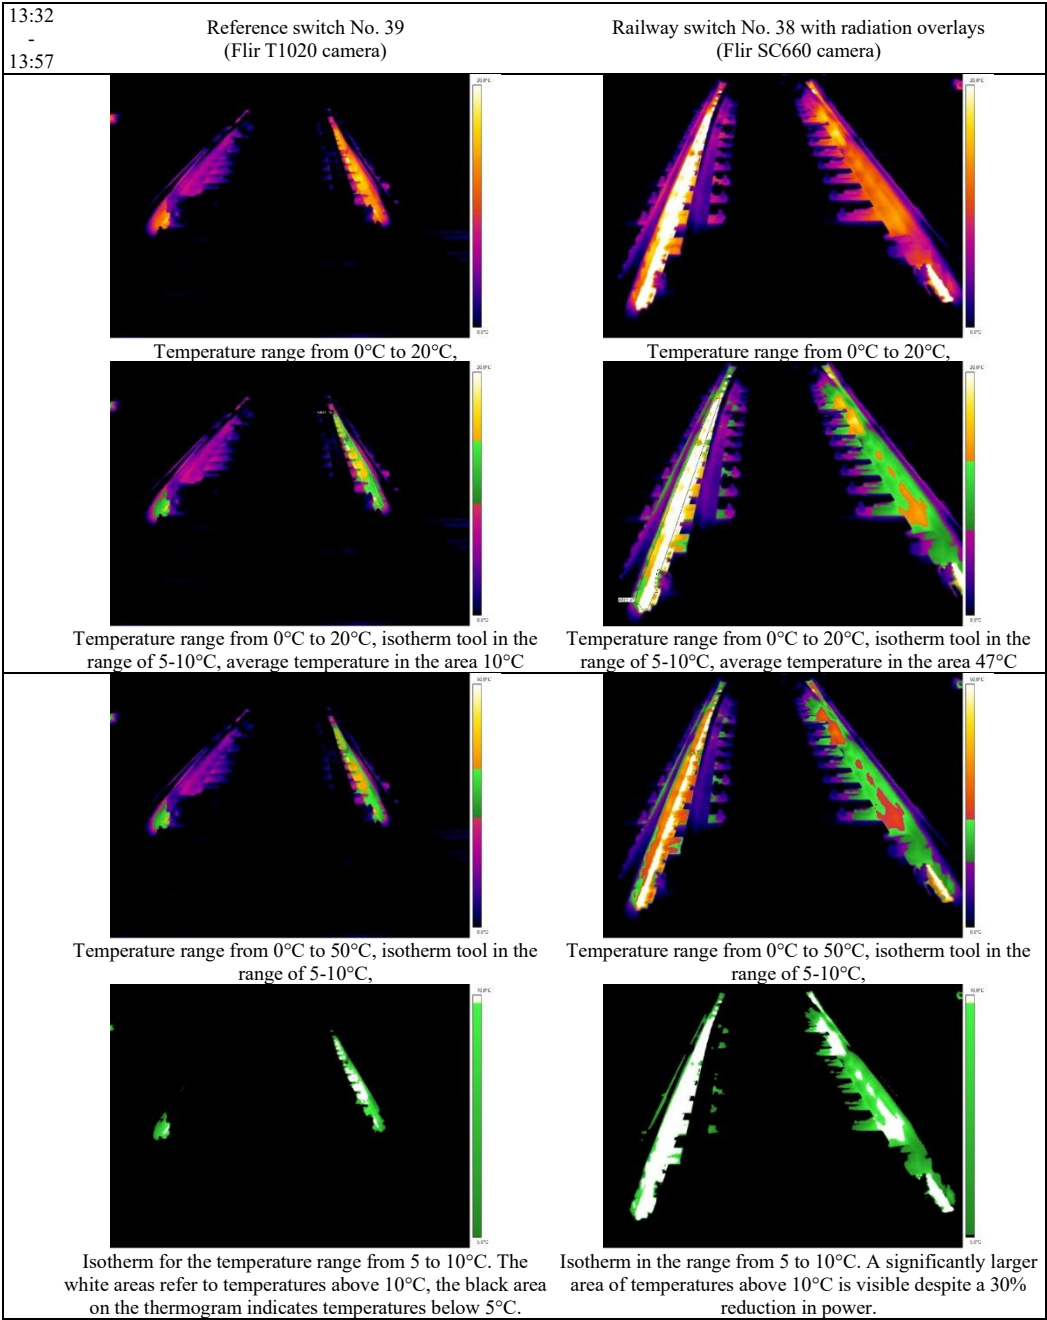
Fig. 7. Thermographic test results for switch number 38 and 39 showing the temperature distribution for the entire area of the studied switches in a heated state

switch in both the main and non-main positions. Thermographic tests were conducted using thermal imaging cameras. Figure 7 shows thermograms that recorded the temperature distribution for the entire area of the monitored switch section in a heated state, supplemented with photos of the monitored area.

Heaters with increased heating surface are clearly visible on the thermograms due to the installation of dedicated radiators and radiation overlays. Without radiators, the average temperature in the defined monitored area is 10°C. The use of radiators results in a noticeable increase in the area with a temperature above 10°C, with the average temperature on the surface of the components in the defined area of the switch equipped with radiation overlays being 47°C during the study.
